**Flood Control Project Maintenance
Levee Inspections**

Fall 2019 Levee Maintenance Deficiency Summary Report

San Joaquin River Basin

Reclamation District No. 2075 McMullin

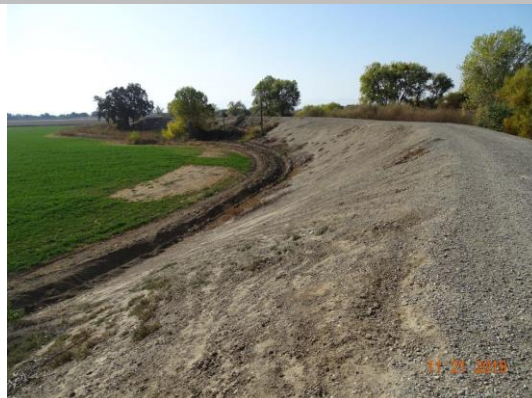
Photo 1 of 1 : FA_2019_RD2075_315_13_20191121_00065.jpg

View of ditch along the landside easement. Fall 2019

LM Start	0.12	Rating **	M	Issue No.	49
LM End	0.12	Issue Type +	En	Location *	
Category	Supplemental			GPS Latitude/Longitude	
				Start	End
Item	DRAFT DWR UCIP Field Study			37.748200°	37.748200°
				-121.289717°	-121.289717°
DWR ID	24735

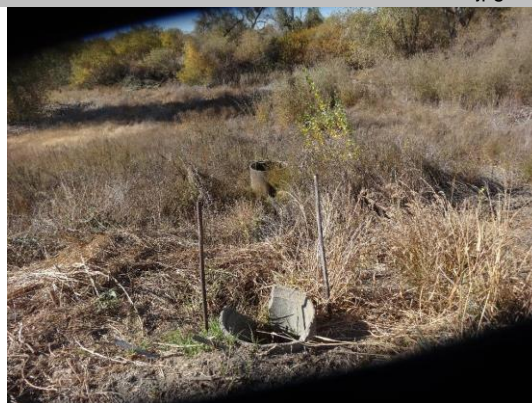
Photo 1 of 3 : UCIP_FA_2019_24663_44022.jpg

Comment Code					
Inspector Comment					
DS_ID:24735 FS_ID:24663 EP_NO: 4736 Repair Type: Non-Urgent Crossing Status: Found UCIP Comments: - pipe not visible on waterside.- no access to concrete riser on waterside.- blocked siphon breaker. FIELD_STRUCT_DESC: 14-inch coated steel drainage discharge pipe through the levee, 4 feet below the crown. Two concrete cutoff walls. Pump mounted on a pile structure in the drainage ditch on the landside (LS). Siphon breaker in a concrete riser on the waterside (WS) slope. Concrete distribution box at the WS toe. (Plans for removing and replacing an existing drainage pipe through the levee authorized under Permit No. 4736, 1964 - Reclamation District No. 2075). [Additional Reference(s): DWR Levee Log, 2005, 12-inch pipe referenced. USACE San Joaquin O&M Manual 3, December 1968, (HLM 0.12), 12-inch pipe referenced]. FS Date: 11/13/2013

WS view: concrete standpipe (top) and concrete pipe riser (bottom) on levee slope.

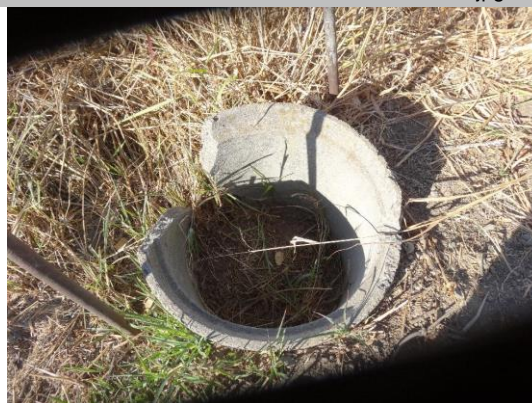
Photo 2 of 3 : UCIP_FA_2019_24663_44021.jpg

WS view: concrete pipe riser with siphon breaker on levee slope.

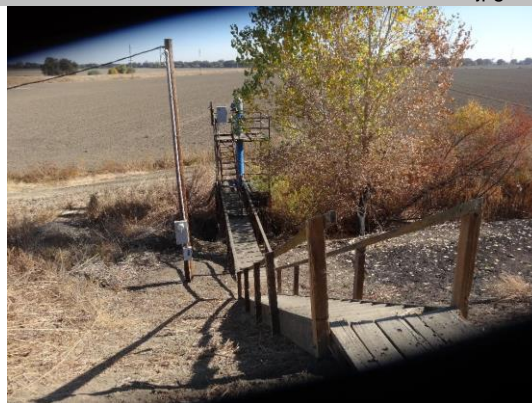
Photo 3 of 3 : UCIP_FA_2019_24663_44020.jpg

LS view: walkway, pump, service pole, and intake structure.

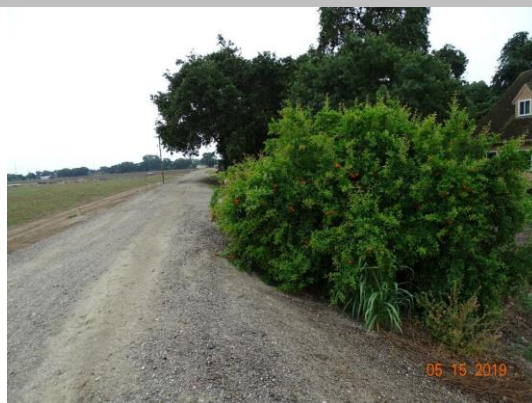
Photo 1 of 1 : FA_2019_RD2075_315_25_20190830_00037.jpg

View of landscape bush on waterside slope in front of residential home. (Spring 2019)

LM Start	0.98	Rating **	M	Issue No.	30
LM End	0.98	Issue Type +	En	Location *	LS
Category	Earthen Levee			GPS Latitude/Longitude	
				Start	End
Item	Encroachments			37.740139°	37.740139°
				-121.281304°	-121.281304°
DWR ID	DWR_RD2075_01_s_2019_30				
Comment Code					
PR : Prunings					
Inspector Comment

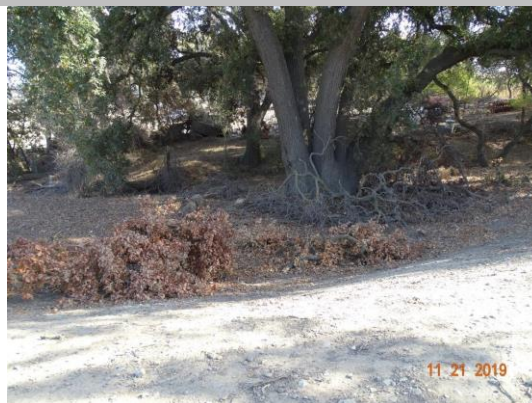
Photo 1 of 1 : FA_2019_RD2075_315_30_20191121_00066.jpg

View of prunings on landside slope. Fall 2019

LM Start	1.15	Rating **	M	Issue No.	36
LM End	1.15	Issue Type +	Ma	Location *	LS
Category	Earthen Levee			GPS Latitude/Longitude	
				Start	End
Item	Encroachments			37.737844 °	37.737844 °
				-121.281650 °	-121.281650 °
DWR ID	DWR_RD2075_01_f_2019_36				
Comment Code					
PR : Prunings					
Inspector Comment

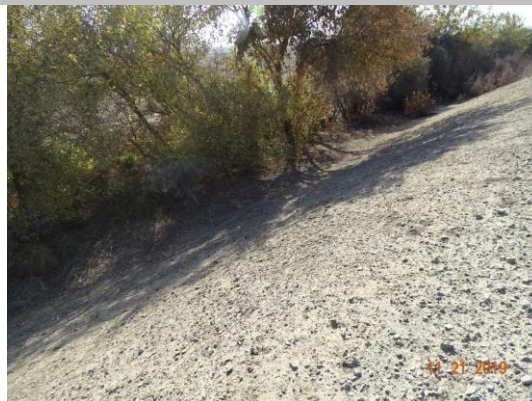
Photo 1 of 2 : FA_2019_RD2075_315_29_20191121_00067.jpg

View of vegetation on landside slope. Fall 2019

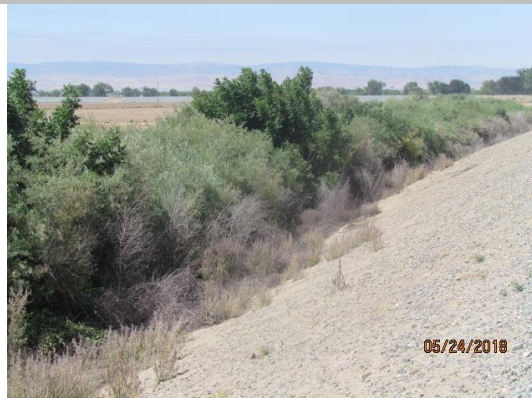
Photo 2 of 2 : FA_2019_RD2075_315_29_20190830_00042.jpg

Looking west at dense veg. at landward toe. (Spring 2018)

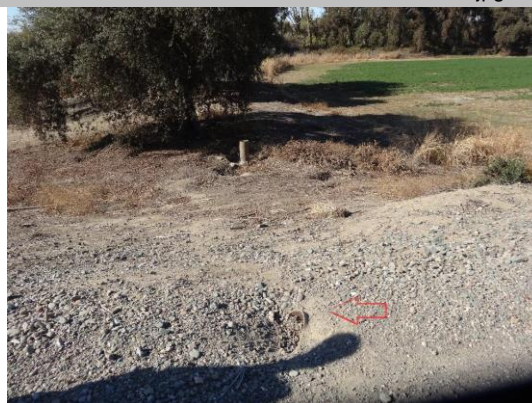
Photo 1 of 3 : UCIP_FA_2019_24666_45600.jpg

Comment Code					
Inspector Comment					
DS_ID:24737					
FS_ID:24666					
EP_NO: N/A					
Repair Type: Non-Urgent					
Crossing Status: Found					
UCIP Comments: - service pole on landside.- looks abandoned.					
Walkway in dilapidated condition.					
FIELD_STRUCT_DESC: 16-inch steel drainage discharge pipe through the levee, 4.5 feet below the crown. Corrugated metal cutoff wall. Pump mounted on a pile structure in a drainage ditch on the landside (LS).					
Siphon breaker in a corrugated metal pipe (CMP) riser on the waterside (WS) slope. [Additional Reference(s): DWR Levee Log, 2005. USACE San Joaquin O&M Manual 3, December 1968, (HLM 2.30)].					
FS Date: 11/13/2013

WS view: concrete standpipe (top) and steel pipe riser (bottom marked) on levee slope.

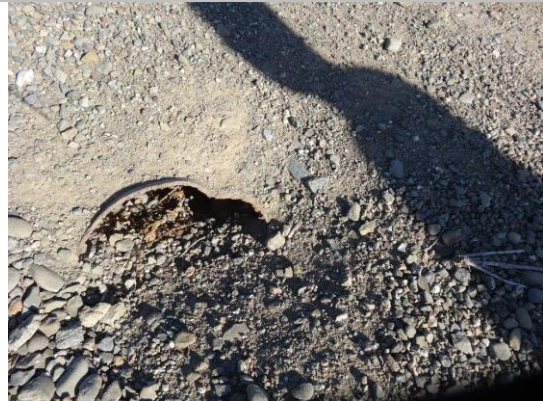
Photo 2 of 3 : UCIP_FA_2019_24666_44030.jpg

WS view: blocked siphon breaker in steel pipe riser on levee slope.

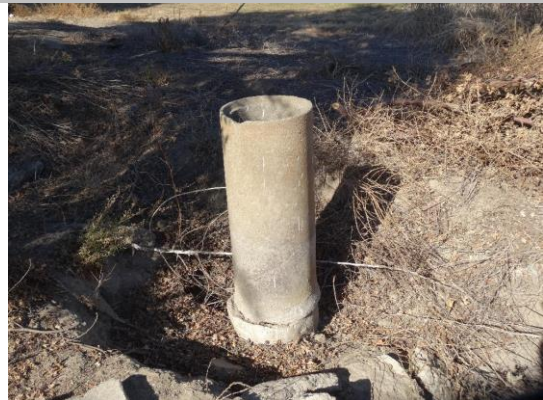
Photo 3 of 3 : UCIP_FA_2019_24666_44029.jpg

WS view: concrete standpipe on levee toe.

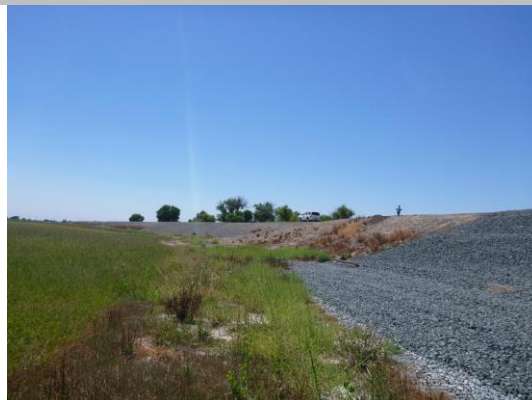
LM Start	2.32	Rating **	A/W	Issue No.	15
LM End	2.78	Issue Type +	Ma	Location *	LS
Category	Supplemental			GPS Latitude/Longitude	
				Start	End
Item	2017 Storm Damage			37.731200 °	37.724900 °
				-121.293400 °	-121.293800 °
DWR ID	LMA-306

Comment Code					
Inspector Comment					
Levee Evaluation Comments					
Description:Sinkholes have formed along the landside levee toe as a result of the high water. The cause of the sinkholes is not clear, but a similar phenomenon in this area is believed to have caused the levee breach earlier this year. Further geotechnical investigation is needed.					
Site ID No:479					
Site Designation:LMA-306					
Repair Type: Stability					
Rating:Area of Concern					
Field Date:7/26/2017					
Notes: Sink holes appear to have already been filled. 10/23/17: LMA has removed pipes (parallel to levee) in this area, and drainage ditch has been relocated to approx 60 feet away from levee toe. Known sandy soils in region may contribute to sinkholes.

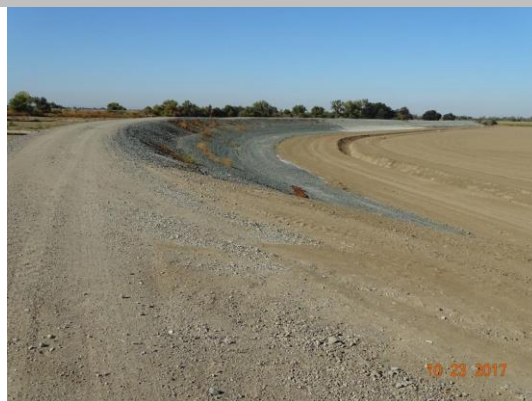
Photo 3 of 3 : FA_2019_RD2075_315_15_20190830_00016.jpg

Item	2017 Storm Damage		37.731200°	37.724900°								
			-121.293400°	-121.293800°								
DWR ID	LMA-306											
Comment Code												
Inspector Comment												
<p>Levee Evaluation Comments Description: Sinkholes have formed along the landside levee toe as a result of the high water. The cause of the sinkholes is not clear, but a similar phenomenon in this area is believed to have caused the levee breach earlier this year. Further geotechnical investigation is needed. Site ID No: 479 Site Designation: LMA-306 Repair Type: Stability Rating: Area of Concern Field Date: 7/26/2017 Notes: Sink holes appear to have already been filled. 10/23/17: LMA has removed pipes (parallel to levee) in this area, and drainage ditch has been relocated to approx 60 feet away from levee toe. Known sandy soils in region may contribute to sinkholes.</p>

10/23/17: LMA has removed pipes (parallel to levee) in this area, and drainage ditch has been relocated to approx 60 feet away from levee toe. Known sandy soils in region may contribute to sinkholes.

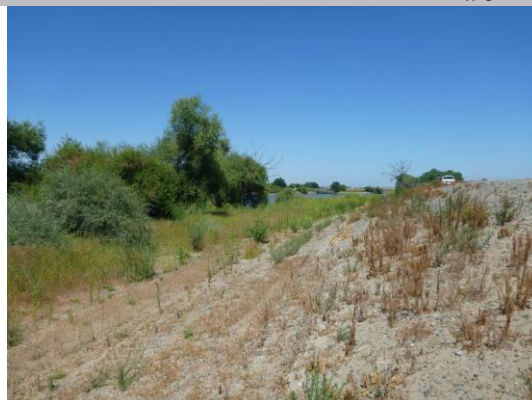
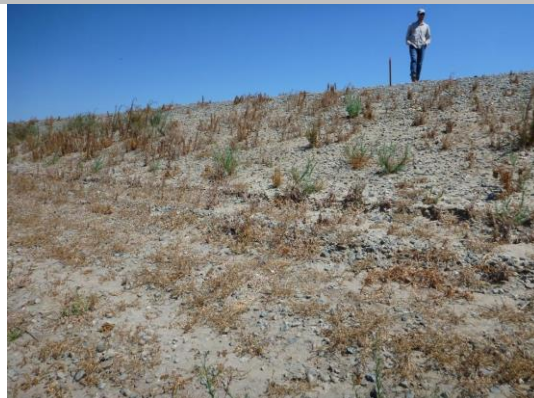
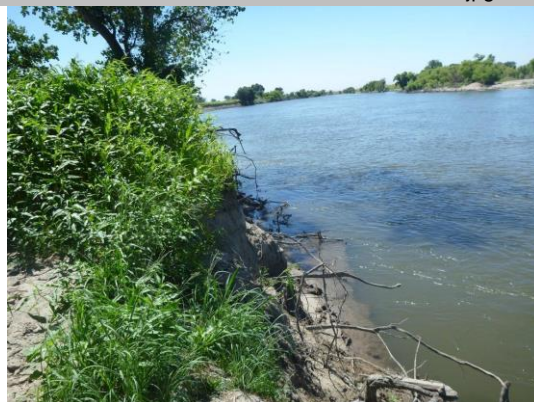
LM Start	2.74	Rating **	A/W	Issue No.	16							
LM End	2.84	Issue Type +	Ma	Location *	WS							
Category	Supplemental		GPS Latitude/Longitude									
			Start	End

Item	2017 Storm Damage		37.725200°	37.724000°								
			-121.294400°	-121.293200°								
DWR ID	LMA-307											
Comment Code												
Inspector Comment												
<p>Levee Evaluation Comments Description: Slope protection repairs are needed along the waterside slope due to erosion. Based upon levee inspections, it was determined the waterside levee slopes were eroding, deteriorating and degrading in concave pocket sections at various locations along this levee reach. The eroded levee sections need to be restored back to design standards to prevent further deterioration of the damaged levee sections. Site ID No: 480 Site Designation: LMA-307 Repair Type: Erosion Rating: Area of Concern Field Date: 7/26/2017 Notes: Low priority because of the wide berm. Could not see all of the bank because of vegetation. Rock was placed on LS here during this years (2017) storms.</p>

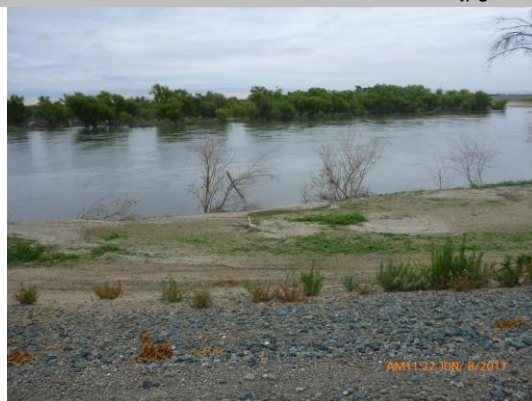
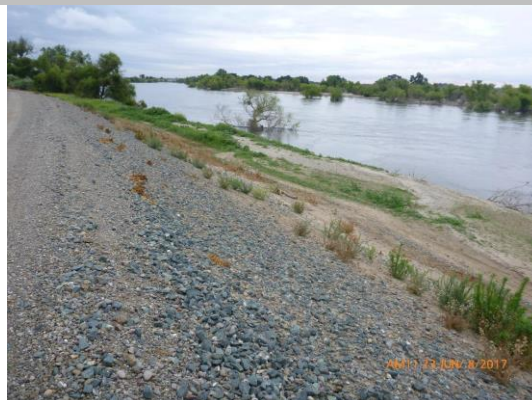
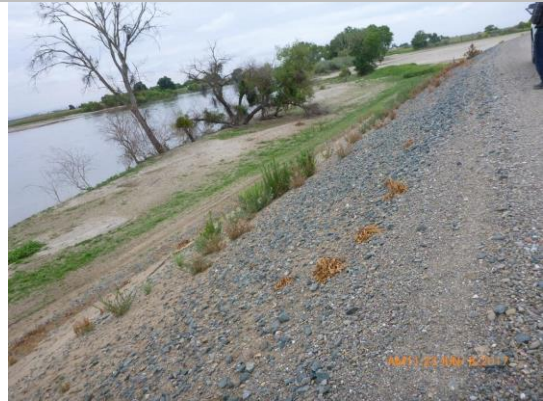
LM Start	2.77	Rating **	A/W	Issue No.	14
LM End	2.83	Issue Type +	Ma	Location *	WS
Category	Supplemental			GPS Latitude/Longitude	
				Start	End
Item	2017 Storm Damage			37.724810°	37.724207°
				-121.294150°	-121.293308°
DWR ID	LMA-35				
Comment Code					
Inspector Comment					
Levee Evaluation Comments					
Description:					
Site ID No:81					
Site Designation:LMA-35					
Repair Type: Erosion					
Rating:Area of Concern					
Field Date:6/8/2017					
Notes: no damage present 10/23/17: Photos taken of vertical eroded low-flow bank approximately 20 feet from waterside levee toe. Area is composed of loose sand. Sandbar in channel may direct current toward this area.

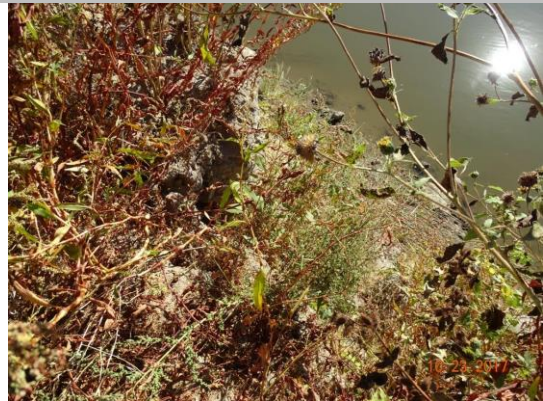
Photo 4 of 6 : FA_2019_RD2075_315_14_20190830_00011.jpg

View down through erosion rut in bank. 10/23/17: Photos taken of vertical eroded low-flow bank approximately 20 feet from waterside levee toe. Area is composed of loose sand. Sandbar in channel may direct current toward this area.

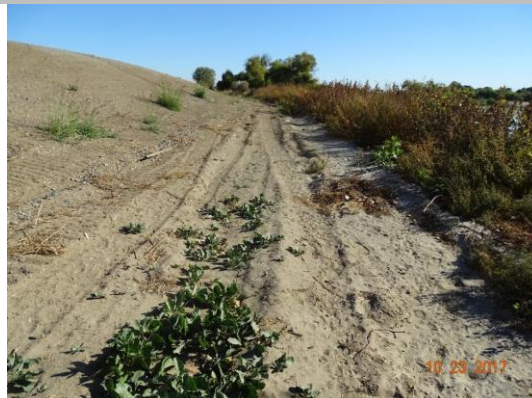
Photo 5 of 6 : FA_2019_RD2075_315_14_20190830_00012.jpg

View upstream showing narrow distance between levee toe and vertical bank. 10/23/17: Photos taken of vertical eroded low-flow bank approximately 20 feet from waterside levee toe. Area is composed of loose sand. Sandbar in channel may direct current toward this area.

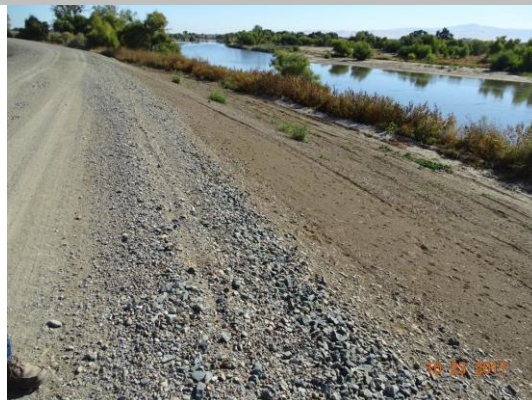
Photo 6 of 6 : FA_2019_RD2075_315_14_20190830_00013.jpg

View upstream showing narrow distance between levee toe and vertical bank. 10/23/17: Photos taken of vertical eroded low-flow bank approximately 20 feet from waterside levee toe. Area is composed of loose sand. Sandbar in channel may direct current toward this area.

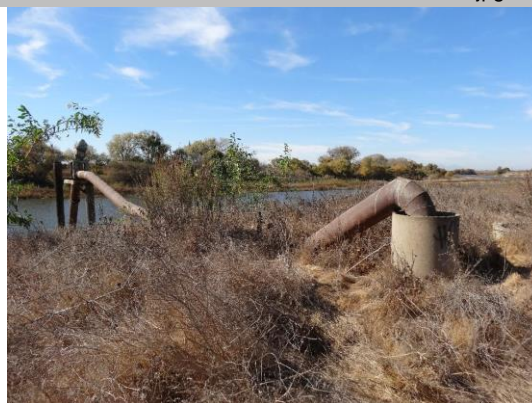
Photo 1 of 3 : UCIP_FA_2019_41721_45982.jpg

Comment Code					
Inspector Comment					
DS_ID:24746					
FS_ID:41721					
EP_NO: N/A					
Repair Type: Non-Urgent					
Crossing Status: Found					
UCIP Comments: Several concrete structure with Alfalfa valve. Only steel pipe visible on river bank. Service pole on waterside.New field discovered crossing.					
FIELD_STRUCT_DESC: 10-inch polyvinyl chloride (PVC) irrigation discharge pipe through the levee, at an unknown depth. Slant pump on the riverbank. Distribution box on the waterside (WS) berm. Concrete U-shaped headwall and open outlet on the landside (LS) toe. Crossing was field discovered. (Plans to install a slant pump on the riverbank authorized under Permit No. 5484, 1966 - Jack Clinton).					
FS Date: 11/13/2013

WS view: slant pump and concrete distribution box on levee berm.

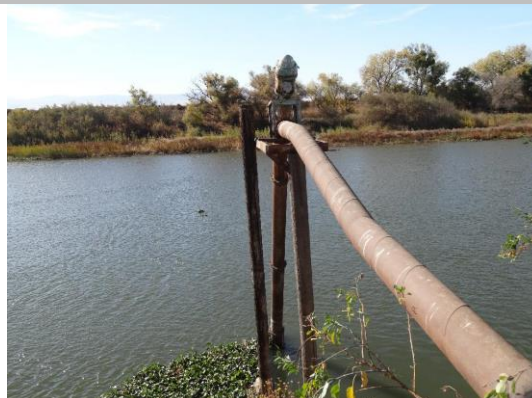
Photo 2 of 3 : UCIP_FA_2019_41721_45981.jpg

WS view: slant pump on timber pile in the stream.

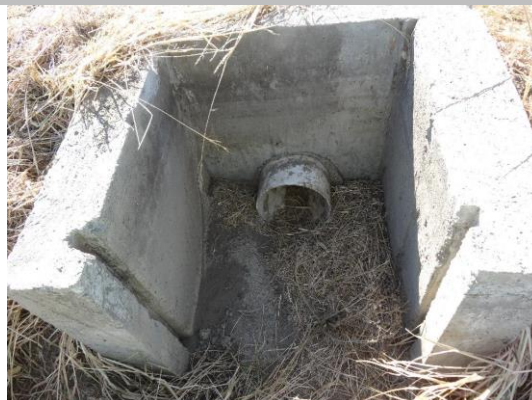
Photo 3 of 3 : UCIP_FA_2019_41721_45980.jpg

LS view: concrete U type headwall on levee toe and open PVC pipe.

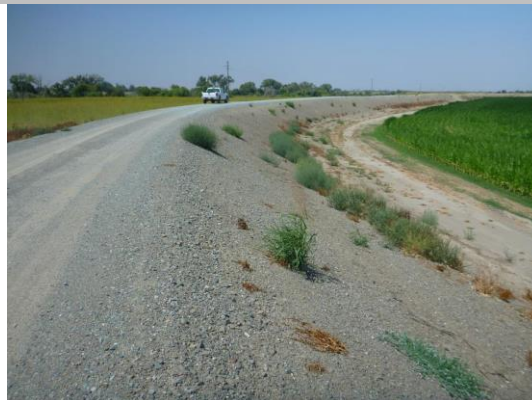
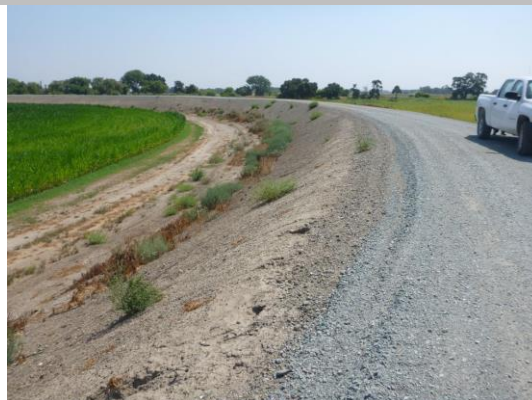
LM Start	3.90	Rating **	A/W	Issue No.	18
LM End	3.95	Issue Type +	Ma	Location *	WS
Category	Supplemental			GPS Latitude/Longitude	
				Start	End
Item	2017 Storm Damage			37.713388 °	37.713492 °
				-121.280018 °	-121.278982 °
DWR ID	LMA-482

Description: Slope protection repairs are needed along the waterside slope due to erosion and riprap displacement from high water. Based upon levee inspections, it was determined the waterside levee slope is eroding, deteriorating, and degrading. The eroded levee sections need to be restored back to design standards to prevent further deterioration and damage.

10/23/17: There was no riprap in this area (contrary to previous comment). Erosion sites have been repaired by LMA.

Notes: 10/23/17: There was no riprap in this area. Erosion sites have been repaired by LMA.

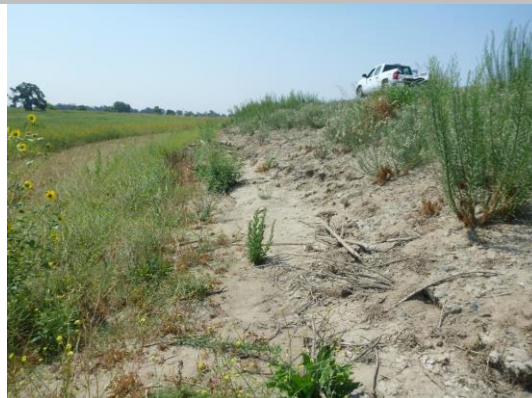
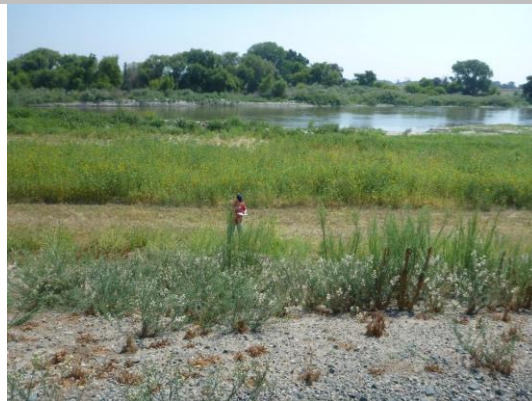
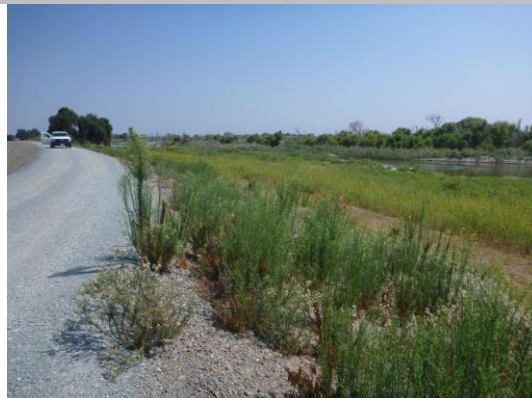
LM Start	4.00	Rating **	A/W	Issue No.	19
LM End	4.04	Issue Type +	Ma	Location *	WS
Category	Supplemental			GPS Latitude/Longitude	
				Start	End
Item	2017 Storm Damage			37.714048 °	37.714630 °
				-121.278363 °	-121.278263 °
DWR ID	LMA-483				
Comment Code					
Inspector Comment					
Levee Evaluation Comments					
Description:Slope protection repairs are needed along the waterside slope due to erosion and riprap displacement from high water. Based upon levee inspections, it was determined the waterside levee slope is eroding, deteriorating, and degrading. The eroded levee sections need to be restored back to design standards to prevent further deterioration and damage.					
Site ID No:577					
Site Designation:LMA-483					
Repair Type: Erosion					
Rating:Area of Concern					
Field Date:8/10/2017					
Notes:

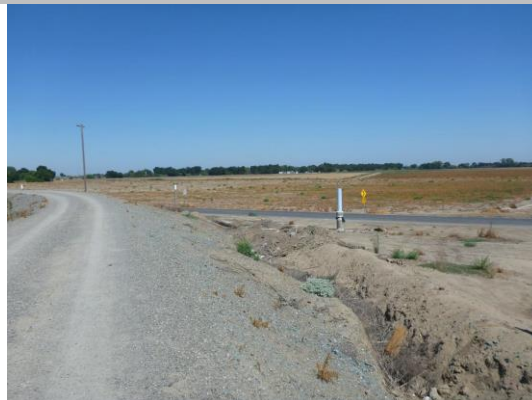
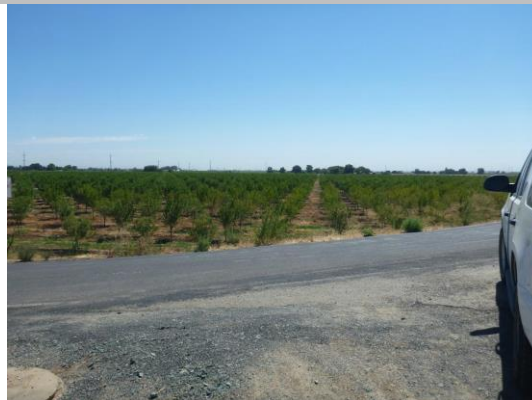
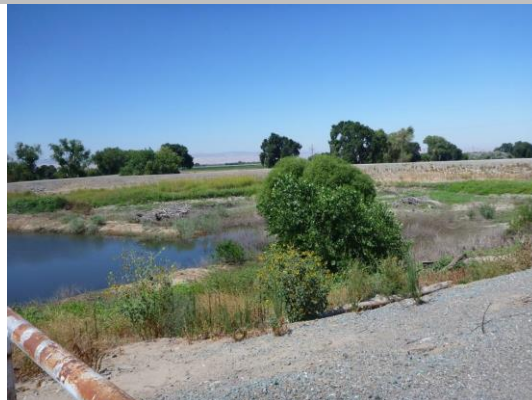
LM Start	4.95	Rating **	A/W	Issue No.	20
LM End	5.20	Issue Type +	Ob	Location *	LS
Category	Supplemental			GPS Latitude/Longitude	
				Start	End
Item	2017 Storm Damage			37.727200°	37.728900°
				-121.277800°	-121.275200°
DWR ID	LMA-308				
Comment Code					
Inspector Comment					
Levee Evaluation Comments					
Description: Heavy seepage was observed during the high water this year 2017.					
Site ID No:481					
Site Designation:LMA-308					
Repair Type: Seepage					
Rating:Area of Concern					
Field Date:7/26/2017					
Notes: No evidence of flood fight here, but the orchard trees next to the levee are looking a little yellow compared to the others.

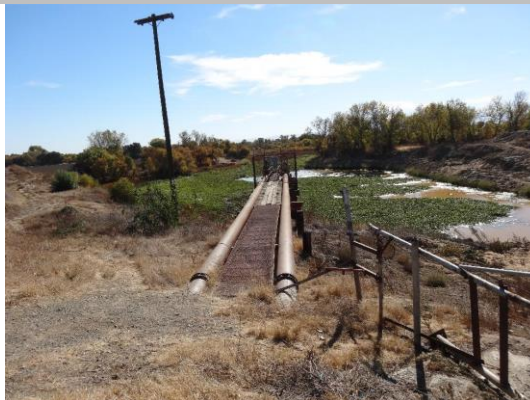
Photo 1 of 3 : UCIP_FA_2019_50209_45603.jpg

WS view: two pipes, walkway to pump and pile structure in the stream.

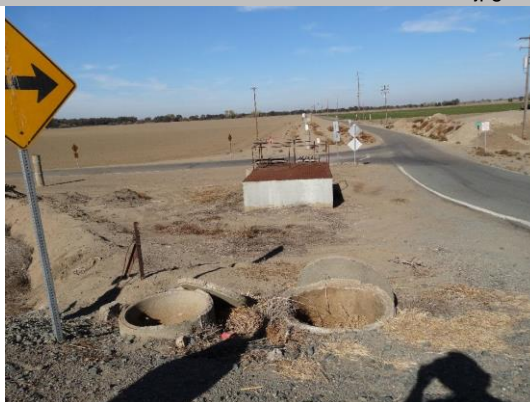
Photo 2 of 3 : UCIP_FA_2019_50209_45602.jpg

LS view: siphon breakers in concrete pipe risers (bottom) on levee slope. Concrete distribution box on levee toe (top).

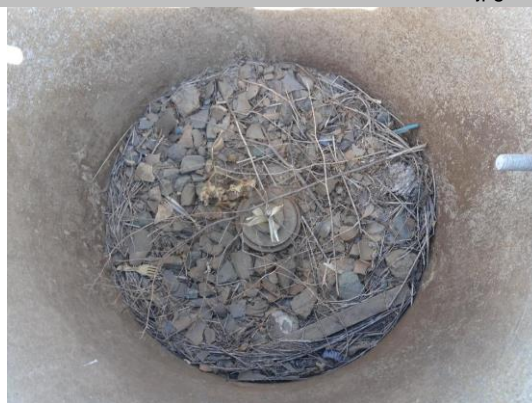
Photo 3 of 3 : UCIP_FA_2019_50209_45605.jpg

LS view: siphon breaker in concrete pipe riser on levee slope.

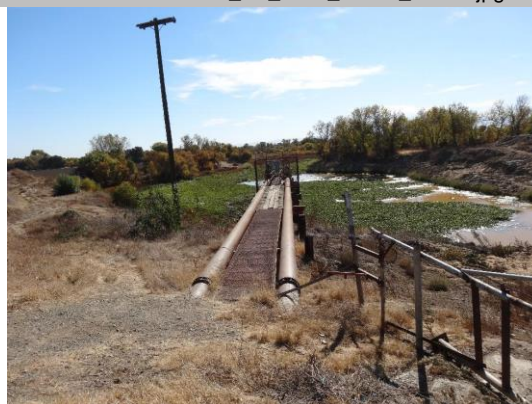
Photo 1 of 3 : UCIP_FA_2019_25184_45608.jpg

WS view: two pipes, walkway to pump and pile structure in the stream.

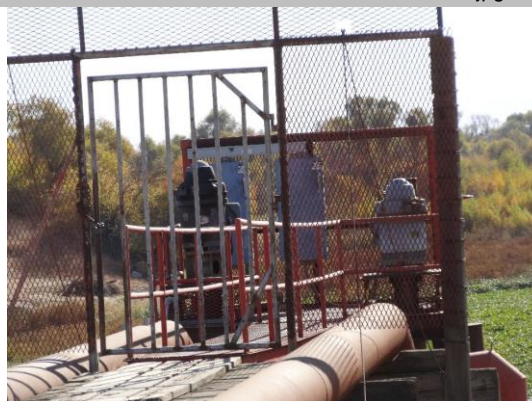
Photo 2 of 3 : UCIP_FA_2019_25184_45607.jpg

WS view: closer view of two pumps and platform in the stream.

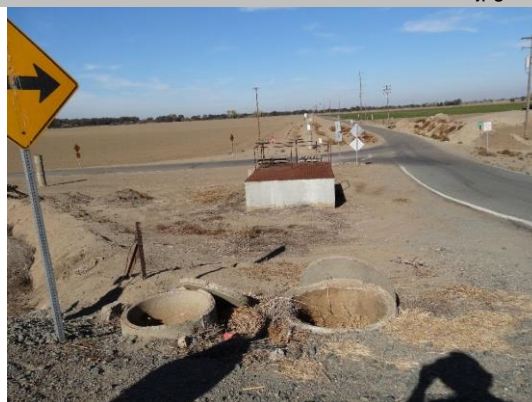
Photo 3 of 3 : UCIP_FA_2019_25184_45606.jpg

LS view: siphon breakers in concrete pipe risers (bottom) on levee slope. Concrete distribution box on levee toe (top).

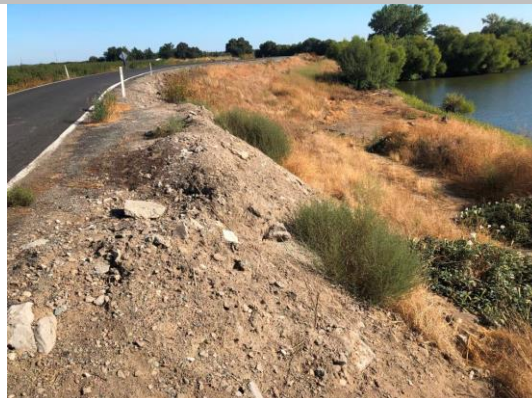
Photo 1 of 3 : SJR2019_RD2075U01RM64.34_1.jpg

Upstream view of the erosion site.

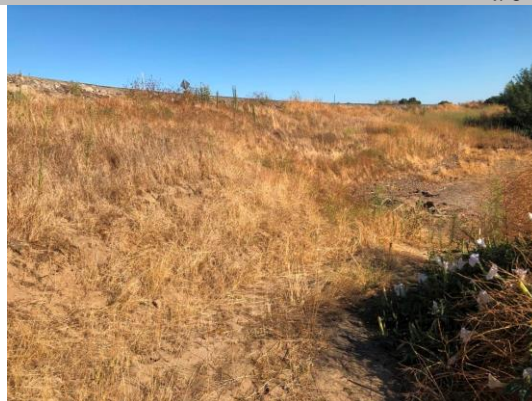
Photo 2 of 3 : SJR2019_RD2075U01RM64.34_5.jpg

Close-up view of the site.

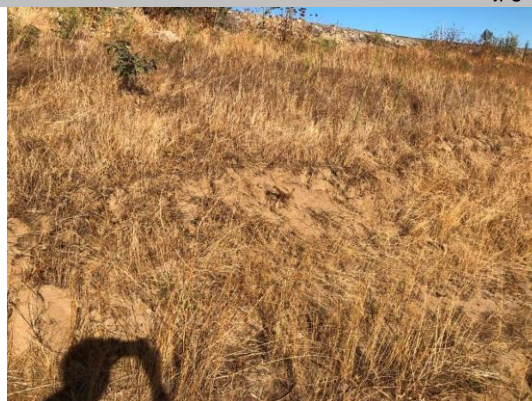
Photo 3 of 3 : SJR2019_RD2075U01RM64.34_6.jpg

Looking at the eroded levee slope.

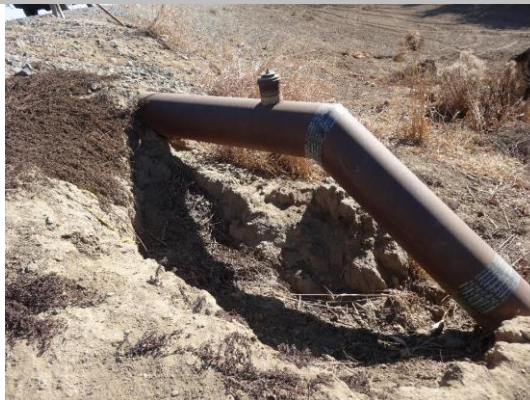
Photo 1 of 3 : UCIP_FA_2019_50191_44262.jpg

WS view: siphon breaker on steel pipe on levee slope. Huge soil erosion due to siphon breaker leakage.

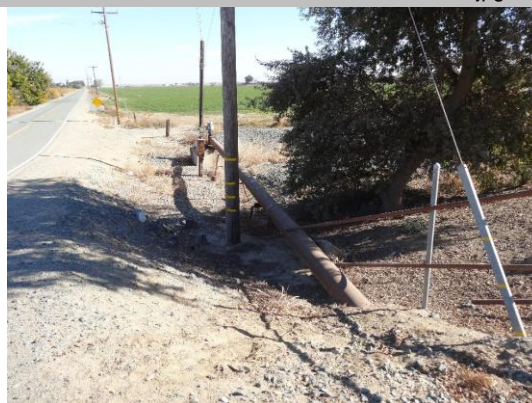
Photo 2 of 3 : UCIP_FA_2019_50191_44261.jpg

LS view: pipe, pump and concrete sump in the drain ditch.

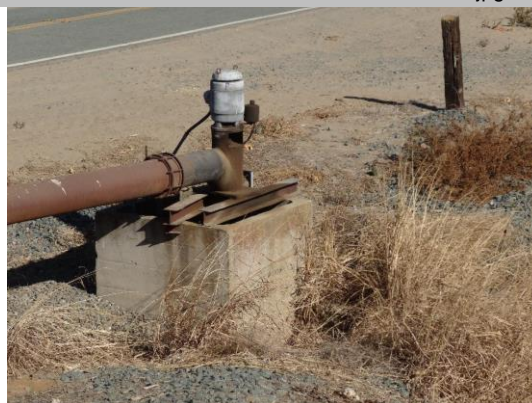
Photo 3 of 3 : UCIP_FA_2019_50191_44260.jpg

LS view: closer view of pipe, pump and concrete sump in the drain ditch.

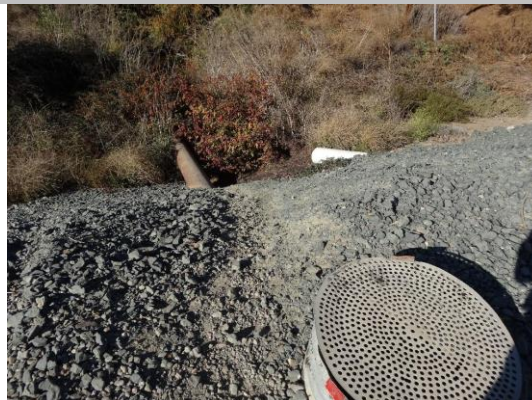
Photo 1 of 3 : UCIP_FA_2019_50213_45613.jpg

WS view: CMP riser (bottom) on levee shoulder. Steel pipe (top) and temporary pvc pipe on levee slope.

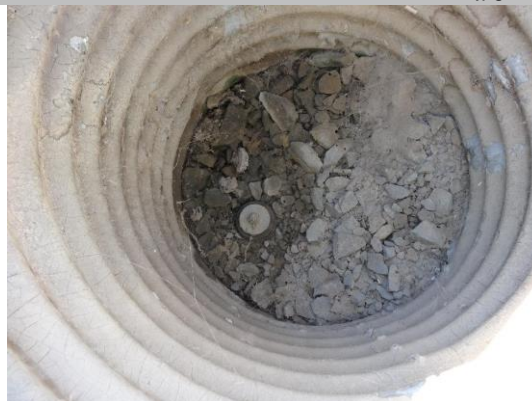
Photo 2 of 3 : UCIP_FA_2019_50213_45612.jpg

WS view: siphon breaker in CMP riser on levee shoulder.

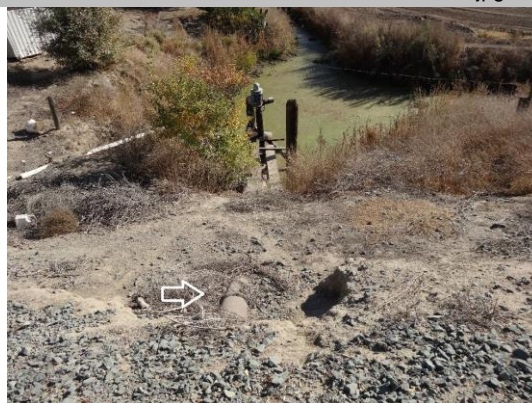
Photo 3 of 3 : UCIP_FA_2019_50213_45614.jpg

LS view: deformed pipe and soil erosion around it (marked bottom). Pipe and pump on pile structure in drain ditch.
